ARBORICULTURAL INVENTORY AND IMPACT ASSESSMENT

TREE PROTECTION STRATEGY

BLACKROCK SENIOR LIVING, BLACKROCK RUGBY CLUB, STRADBROOK ROAD, BLACKROCK

TETRARCH RESIDENTIAL LTD

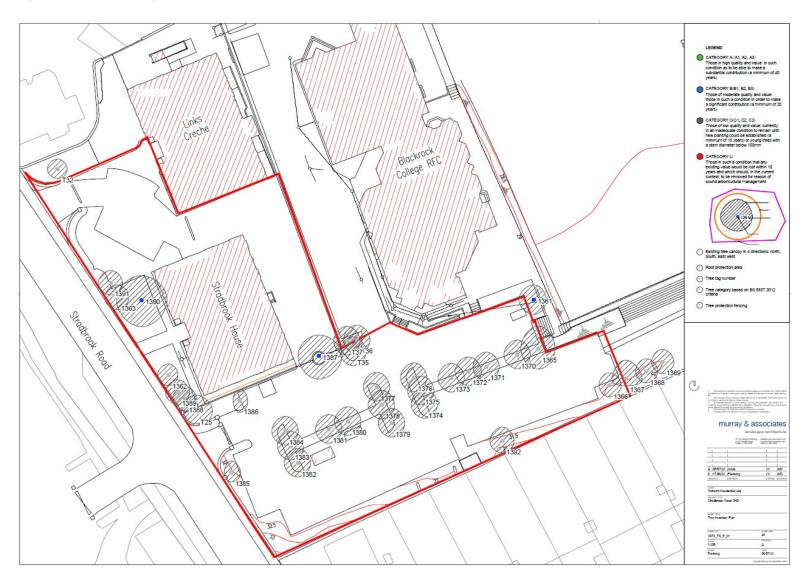
Figure 2 – Tree inventory plan (REF. 1873_TS_P_01)

The majority of trees on the site are in poor condition. This is mainly due to their age and species. All of the trees on the site are to be removed to facilitate the proposed development.

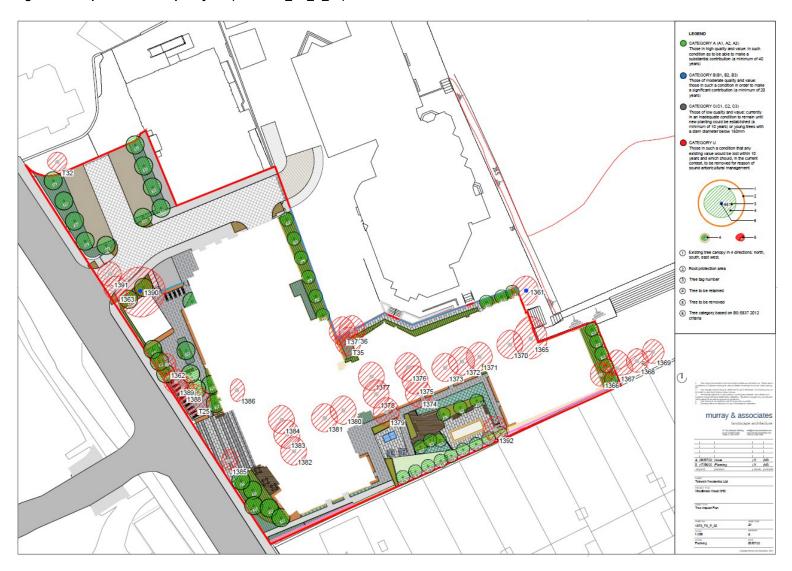
Figure 3 - Proposed landscape layout (REF1873_TS_P_02)

The majority of the tree cover on the site is of limited arboricultural/amenity interest and is in decline, particularly the white birch and cherry species. The proposed development will entail the replanting of tree species on the site which will mitigate the loss of the existing tree cover.
